Review of Poppit Sands Toilets - September 2018

Toilet block owned by: Pembrokeshire County Council

Toilet block maintained by Danfo

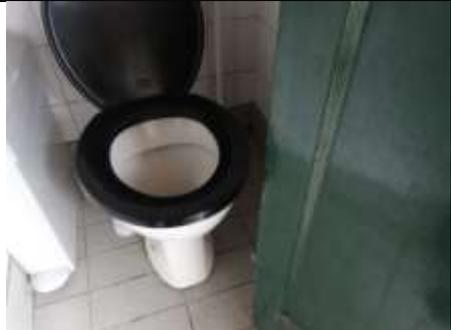
Photo
<p>Ladies' Block</p> <p>Toilet cubicles are not large enough being both narrow and of a short length from door to rear wall.</p> <p>Doors open inwards so when entering the toilet cubicle there is not enough space between the door and the toilet bowl (Fig.1)</p> <p>The depth of the cubicle is demonstrated using a foot to show that edged of door comes to edge of toilet when open, leaving no space to be able to close the door easily (Fig. 2)</p> <p>In order for the door to be closed, those who are in the later stages of pregnancy, have toddlers with them, a babe in arms, are of a larger build or have a temporary disability have to manoeuvre themselves between the side wall and toilet bowl. Given the very narrow space available this is dangerous, particularly for anyone who is potentially off balance through body weight or from carrying a child etc. It would seem that at some point an accident is inevitable given the lack of space.</p>

<p>Figure 1 Space between door and pan</p>

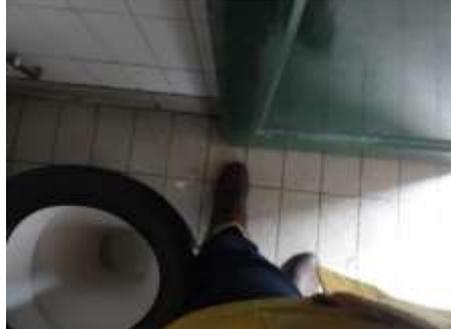
<p>Figure 2 Using foot to show distance</p>

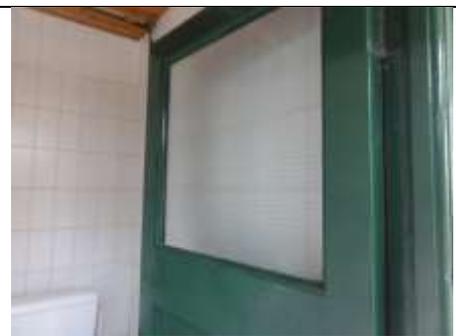
Doors the cubicles in the Ladies toilet block have glass panels in them. Despite being 'obscured', as is evidenced in the attached photographs outlines are clearly visible. Many women feel, quite understandably, uneasy with this as it is an invasion of the privacy of those using the cubicles. (fig 3)

Figure 3 Door from outside

It is questionable as to why the glass panels remain in the doors of the ladies' cubicles when they have been removed and replaced with solid panels in the gentleman's toilets next door.

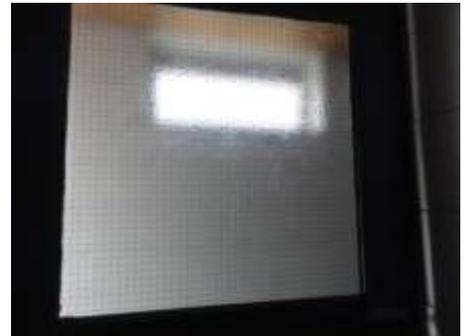
Fig 4, taken from inside of the toilet clearly illustrates that outlines can be easily made out through the glass panel. It is equally easy to make out outlines of anyone within the cubicle.

Figure 4 Glass in door taken from inside

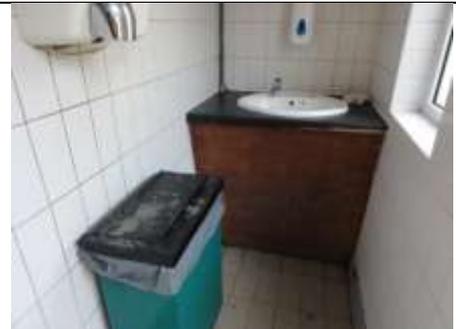
The sink and bin are in an extremely poor state of repair. (Fig 5)

The single sink and bin are in a narrow space close to the door of the block. Given difficulty in accessing the space if the toilet block is busy this does not lead to good hygiene practices.

Figure 5 sink and bin

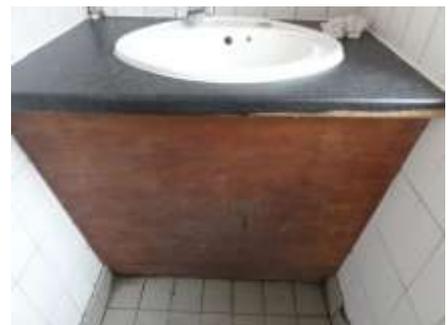
The plywood tacked to the front of the sink is rotting and the work top is chipped (Fig 6)

Figure 6 Rotting and chipped sink unit

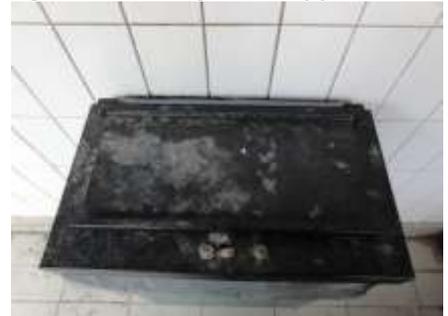
The bin is rusted and chipped (would you want to lift the lid on that after washing your hands?). (fig 7)

Figure 7 Top of bin

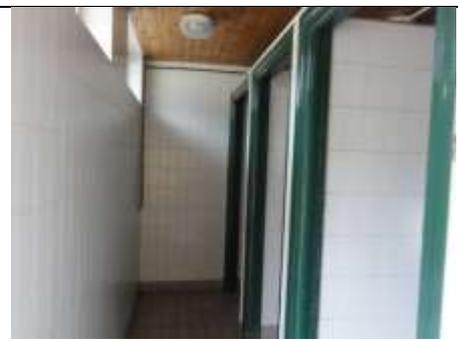
Due to the layout of the toilets there is no room for a baby changing unit. The disabled toilet does have space but because this is fitted with a Radar key it is not accessible to parents with young babies. Comment that mixed use can lead to significant delays is noted. However given the popularity of Poppit as a destination, suitable provision is needed for all.

The Council would also draw to your attention that some disabled older children may need to be changed and they have the right to have the facilities for this to be carried out in a safe, comfortable and dignified environment and not just on the floor of a public toilet
Fig 8, view 1 and Fig 9, view 2 show limited space.

Figure 5 View 1

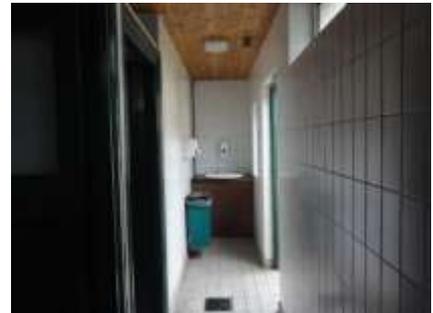
Figure 6 View 2

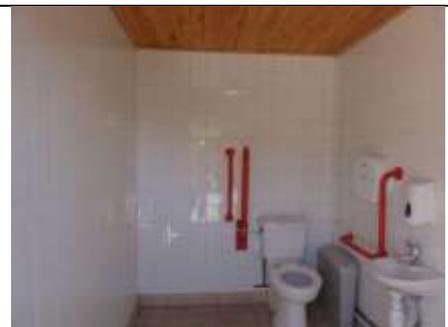
The disabled toilet is by contrast is a clean bright space with plenty of room and could accommodate a baby/child changing platform. (Fig 10)

It is accessed by a Radar key which limits its' use. Some people may only have a temporary disability, (recovering from an illness, injury or operation) but may find using the other available facilities on site a challenge because of this.

Figure 10 Disabled toilet

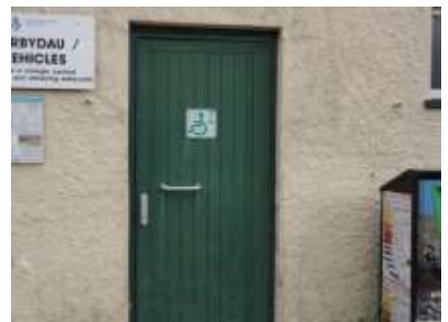
There is a spare Radar key located in the RNLI shop but there is no sign to alert people to this fact. (See Fig. 11 and Fig. 12)

Figure 11 Poppit

Other toilet facilities in Pembrokeshire have notices on the door of the toilets to let people know where a spare key kept. Why is this not the case at Poppit?

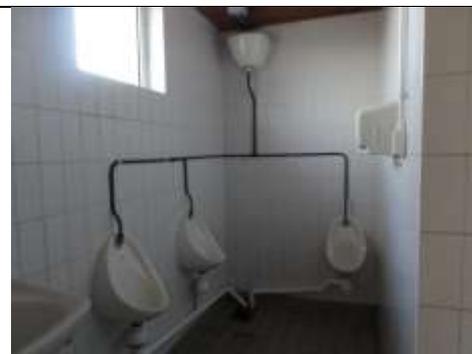
Whilst the Gents side is 'adequate' (with two cubicles and three urinals and a sink) even by the standards of a public toilet facility, it is basic and would benefit from refitting and improvement.

Figure 13 Urinals & sink

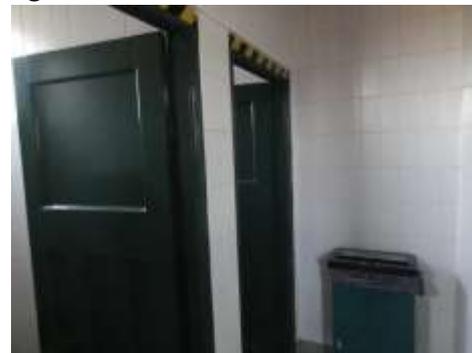
The cubicles, which are deeper than those in the Ladies, are more spacious. (Fig 14)

The cubicles have had the glass in the doors replaced by board thus giving more privacy which is lacking in the Ladies area.

Figure 14 Boarded doors Men's toilets

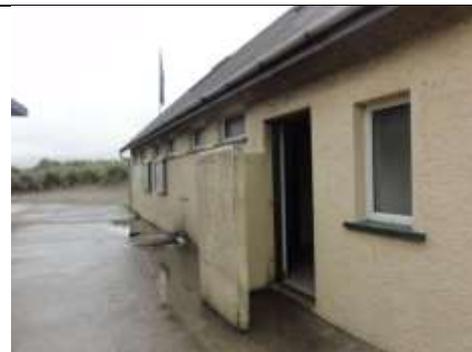
The access (shown to Ladies' side – Fig 15) is extremely difficult to negotiate for those who are in the later stages of pregnancy, have toddlers with them, a babe in arms, or have a temporary disability.

Children's buggies cannot easily be taken into either block and children have to be carried into the block.

The outside of the building is very dingy and needs repainting. The rendering is cracked and discoloured.

Figure 15 Outside

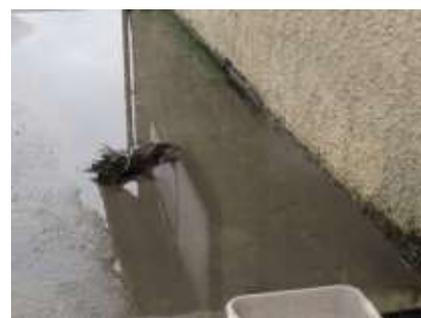
Along the bottom of the outside wall, water collects; it is understood, because of a faulty drain. Sand and mud collect in this area forming a muddy 'soup' which is insanitary and a health hazard. Fig 16

The water is also affecting the rendering.

Figure 16 Water collecting

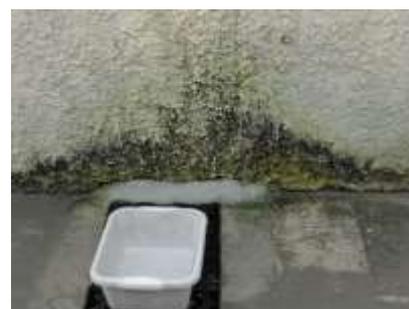
Fig 17

Figure 17 shows the condition of the render adjacent the drain serving the outside tap.

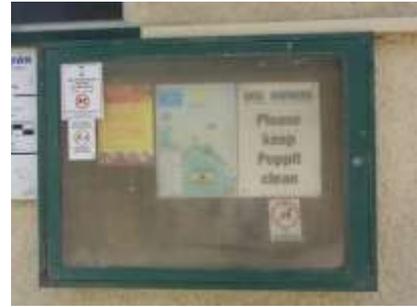
Even the notice boards on the walls of the block are in a disgraceful condition and need replacing. Fig 18
