## **BIODIVERSITY PILOT**

### **Maes Hyfryd (Lower) Verge Map Ref 6e (adjacent to Properties Nos 34-39)**

This report based on last site Visits on 6 & 8 May 2021 (see photographs).

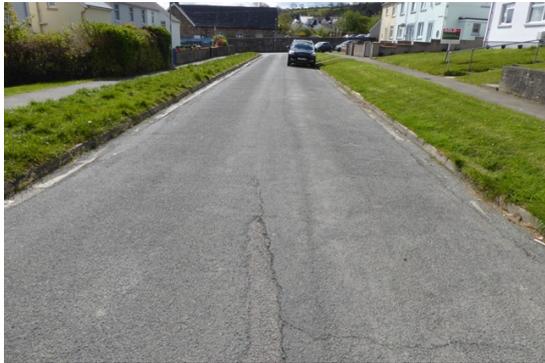
As you can see from the photograph there is no safety issue re ingress onto the path area due to the pilot. Although ( and this is not our contract) there is grass growing onto the path and reducing the width of the pavement which we may wish to advise to PCC ( see photo 2) **(this is NOT connected or caused by our biodiversity pilot but a general H&S issue - a cut would not resolve this it requires edging to remove the matted grass/plant roots!)**.

Photo 1: Indicates uncut verge Map ID 6e Biodiversity Pilot on the left and the cut verge non-pilot on the right. Taken on 10th May 2021. NB. It should be noted that part of the roughness of this uncut verge was caused by residents driving cars over it during the wetter months and it has been advised by a resident, getting stuck in the mud, leaving deep ruts. Some in fill was carried out by the car owner I understand.

Request PCC to make a late May or early June cut as opposed to the planned first cut in July - this would still allow for some of the plants to finish flowering and set seed and reduce the perceived untidiness by some residents by 4-5 weeks and stop further complaints.

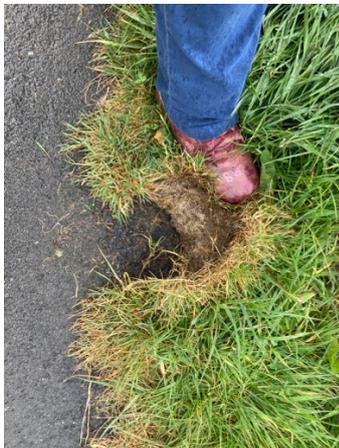
Photo 2 : Shows grass which is growing over pavement area (**Not related** to biodiversity pilot but an H&S issue)
