Tree works following visit by PCC Tree Officer Mr Barry McKee

October 2021

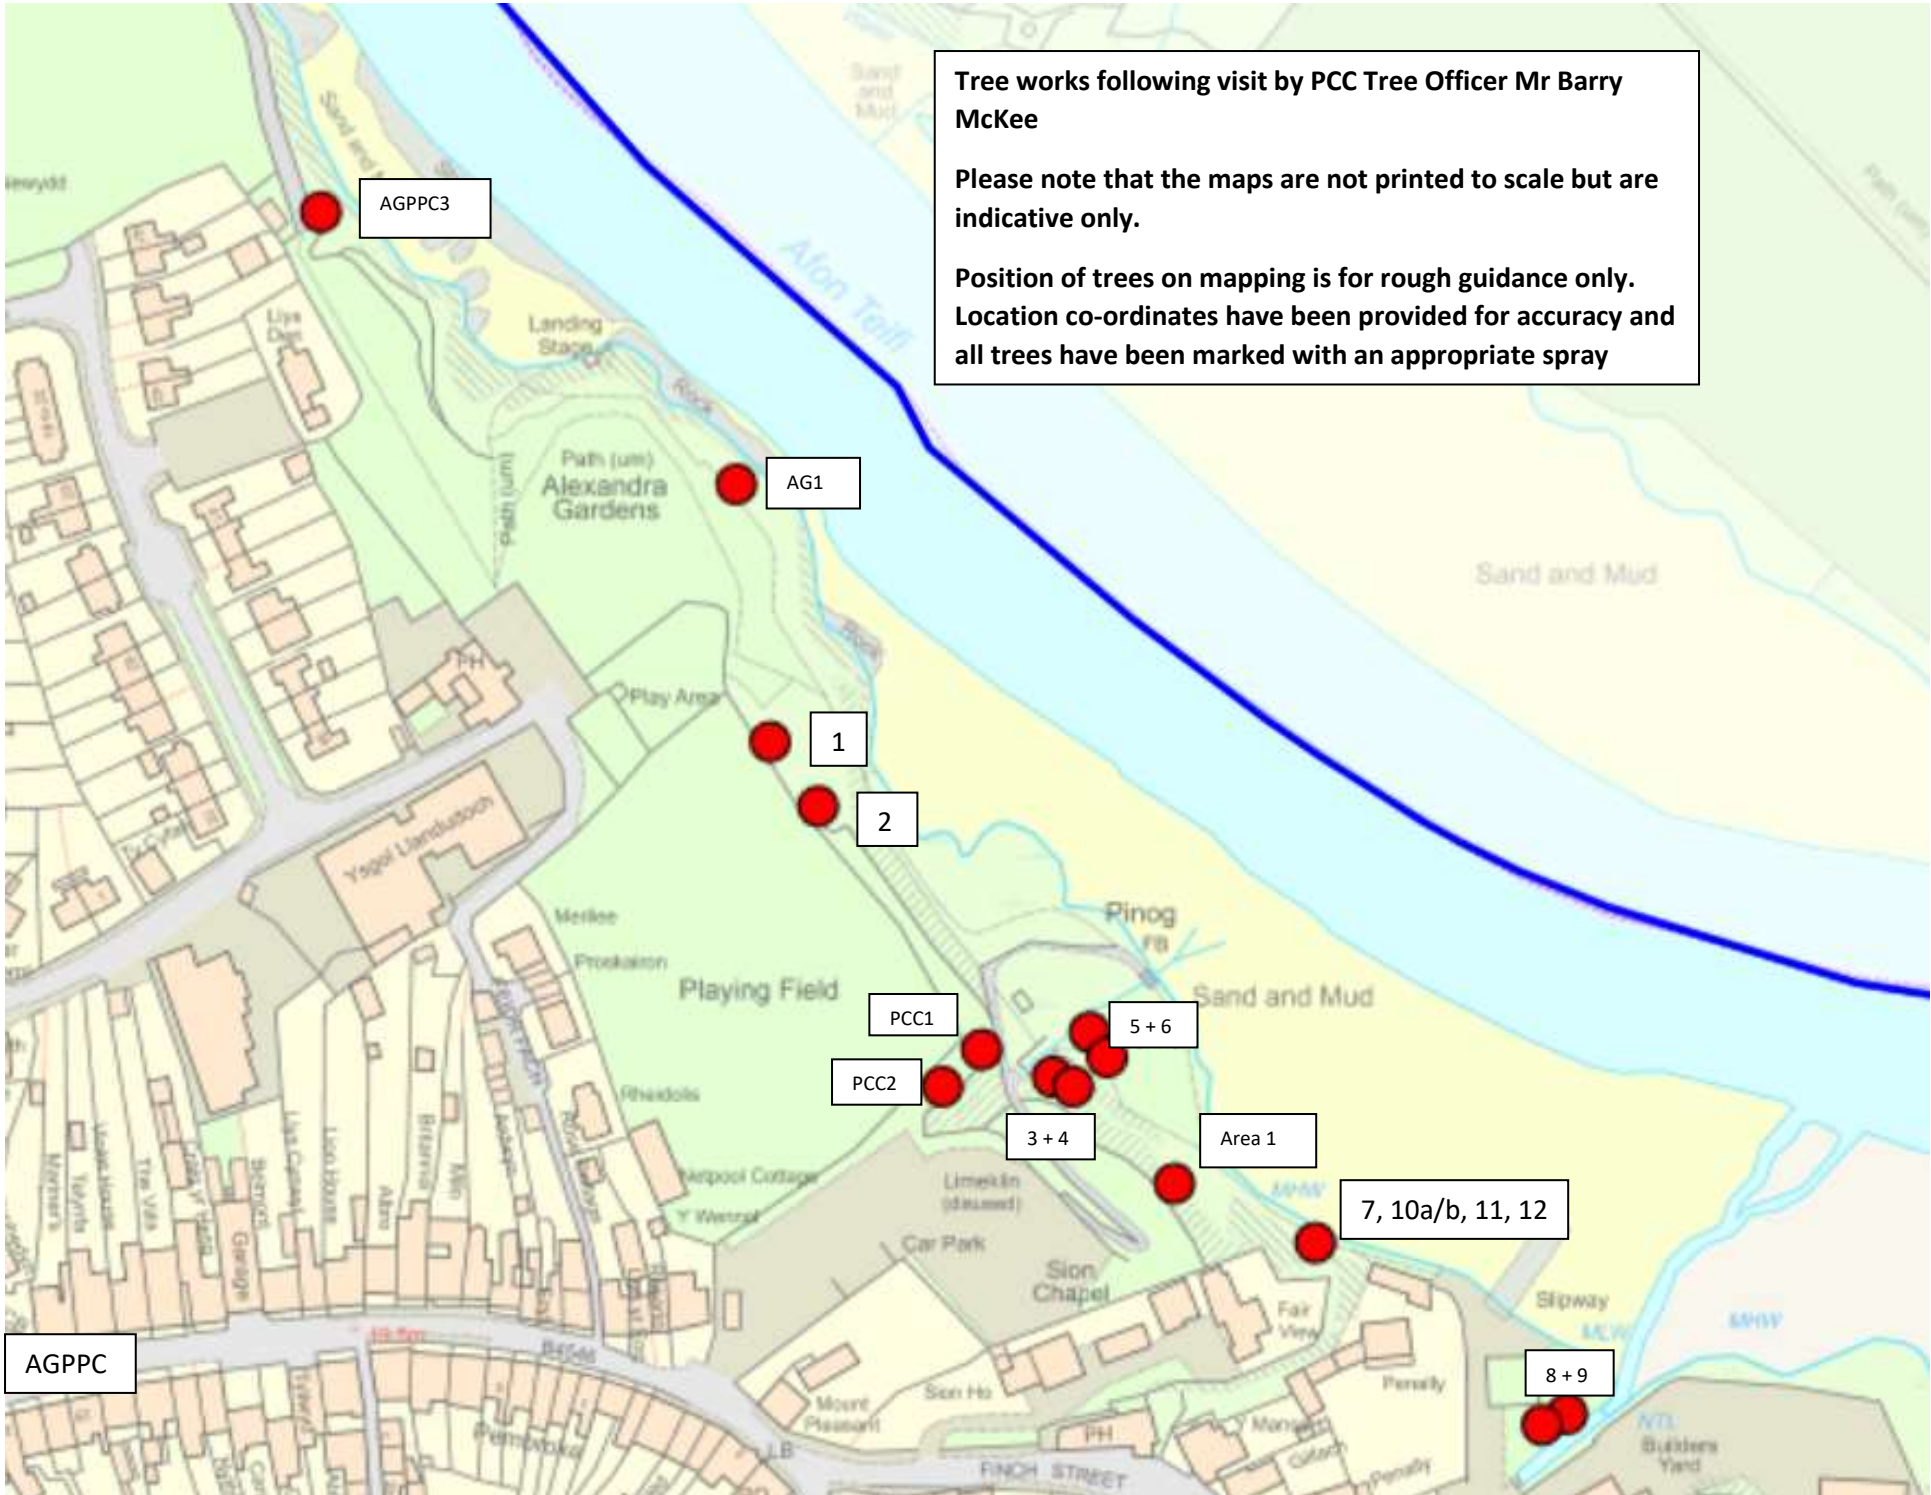
Please note that the maps are not printed to scale but are indicative only.

Position of trees on mapping is for rough guidance only. Location co-ordinates have been provided for accuracy and all trees have been marked with an appropriate spray

Marked	Location	Ownership	Species	Action
1	SN 16514611	SD	Ash	Remove lower branches overhanging path
2	SN 16494612	SD	Hazel	Remove one branch across footpath
				Oak split with hazel growing through it. Obvious rot with fungi present.
PCC1	SN 16504608	SD	Oak	Reduce height by 2/3.
PCC2	SN 16504608	SD	Ash	Monitor
Area 1	SN 16534603	PCC	Ash and elm	Area not easily accessible to public - monitor
3	SN 16524609	SD	Ash	Monitor
4	SN 16524609	SD	Ash	Monitor
5	SN 16534608	SD	Ash	Lower to approx. 5m height
6	SN 16544608	SD	Ash	Remove
7	SN 16574605	SD		Remove low branch overhanging footpath
8	SN 66644599	SD	Ash	Remove
9	SN 16644599	SD	Ash	Monitor
AG1	SN 16454617	SD	Ash	No significant signs of dieback - monitor
AGPPC3	SN 16454617	SD	Ash	Monitor
10a/b	As 7	SD	Elm	Remove multiple trunk and single trunk to rear
11	As 7	SD	Elm	Monitor
12	As 7	SD	Elm	Monitor
