A Clear Culvert reduces the risk of St Dogmaels Flooding

Gill Wislocka 14 10 2018 1st Draft

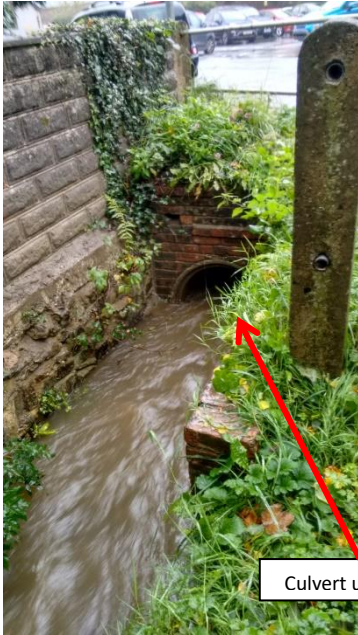
These photos show flow of water into & out of the culvert at High Tide 11am 13 10 2018
The culvert still had capacity despite ~ 90mm of rain falling in the previous 48 hours
High Tide was at 10.55 (4.55m, previous High Tide 4.7m), 998mb & wind Southerly

Stream behind David St
Culvert under B4546 at
11am 13 10 2018

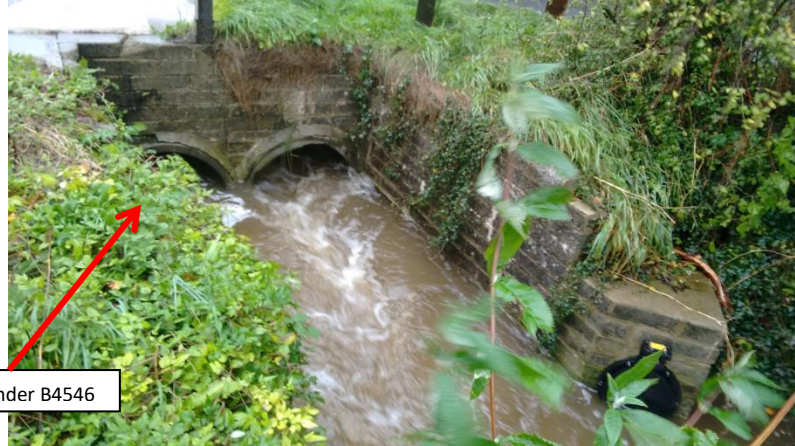
Culvert adjacent
PROW 87/55
Outflow

PCC are awaiting
appropriate
licences to
remove silt & so
increase capacity
of outflow

Culvert outflows for the stream behind David St &
the Cwm Degwel stream at 11am 13 10 2018
Showing also the non-return valve for surface water outflow working

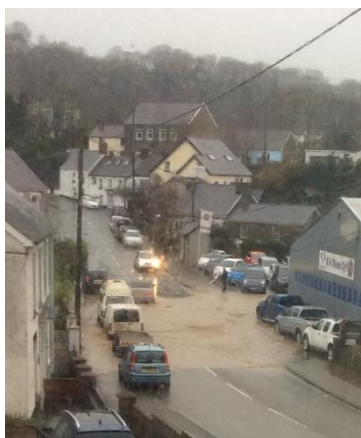
21 January 2018
Floodwater across B4546

In November 2017, Wyn Rees thankfully repaired a damaged section of culvert & removed a traffic cone, 2 half bags of cement, a fence post, sandbags & other debris trapped in the downstream end of the culvert. There has been one flood since 21 Jan 2018. This was caused by a fine mesh grill at the mouth of the culvert. The grill blocked with debris e.g. leaves stopped water flow into the culvert causing water backup/flooding. This grill now been removed and the stream water flows freely at present.

The stream needs to be kept clear of debris & loose stone that could cause blockage in the culvert

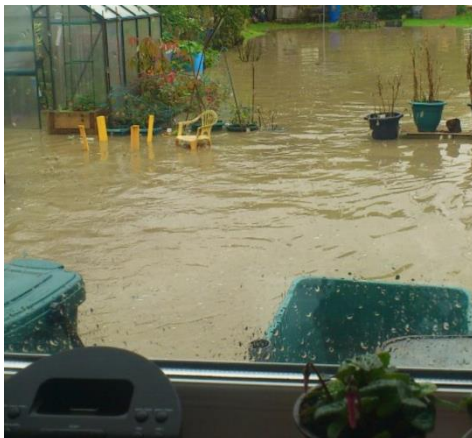
30 March 2017
View from Brooklyn Villa kitchen

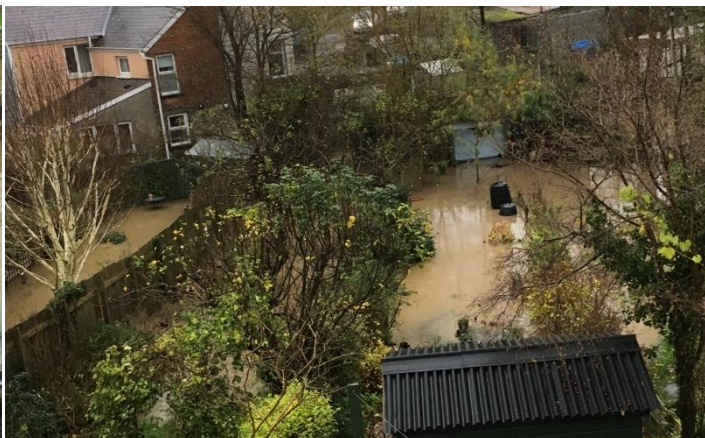
21 November 2017
View of David St back gardens
